# INTRODUCTION MERCEDES 722.3 722.4

Mercedes introduced the 722 models in 1980. The 722.3 is found in most models and the 722.4 was first found in the 190 vehicles. This manual covers the difference between these units in the valve body and governor. The basic components, the pump, gear sets, drums, clutches, bands are the same. This manual covers both the original manufacturers information along with some of the changes and updates. We thank Mercedes Benz for the information and illustrations that have made this booklet possible.

# **MERCEDES 722.3 AND 722.4**

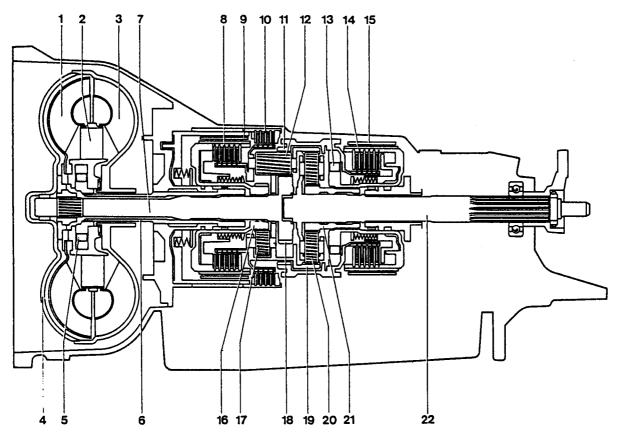
Fig. 368

- 1 Turbine wheel
- Impeller
- 3 Pump wheel
- 4 Converter cover 5 Converter one-way clutch
- 6 Stator shaft
- Input shaft 8 Clutch K 1
- 9 Brake band B 1
- 10 Disc brake B 3
- 11 Ring gear (Ravigneaux planetary unit)
- 12 Wide planet pinion (Ravigneaux planetary unit)
- 13 One-way clutch F 14 Clutch K 2
- 15 Brake band B 2
- Small sun gear (Ravigneaux planetary unit) 16
- 17 Narrow planet pinion (Ravigneaux planetary unit)
  18 Large sun gear (Ravigneaux planetary unit)
- 19 Ring gear behing planetary unit20 Planet pinion rear planetary unit
- 21 Sun gear rear planetary unit 22 Output shaft

Speed	B 1	B 2	В 3	K 1	K 2	F	Reduction
1		X			(X)	×	3.68
2	х	x					2.41
3		×		×			1.44
4				×	X		1
R			×		(X)	×	5.14

(X) K 2 bridges the one-way clutch during deceleration (coasting).

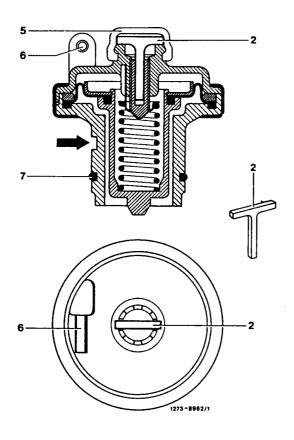
2-Adjusting Key 5-Rubber Cap 6-Vacuum Connection 7-O-ring

A pressure pin for transmitting the movement of the vacuum diaphragm is no longer installed. The vacuum control unit acts directly on the modulating pressure regulating valve.

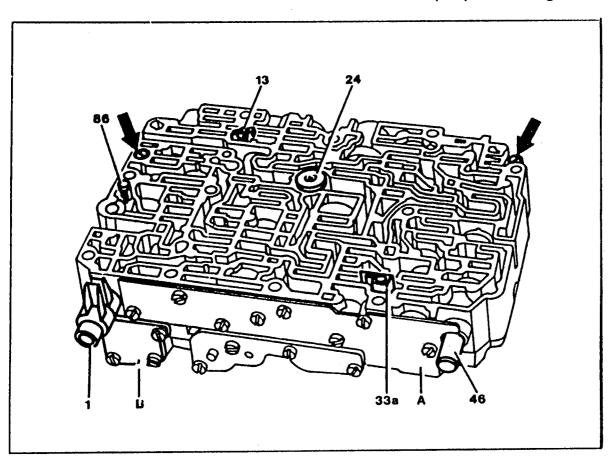
- 13 Plate check valve with bore 33a clamped retainer B2 valve
- 24 Check valve-primary pump 86 Drain Valve LB3

Observe cleanliness when working with the valve body. Do not use fuzzy rags because this can cause hanging of valve and cross leaks. remove screws indicated by arrows, remove valves (13,24,86) and retainer (33a). INSTALLATION NOTE; Tighten screws lightly so that housings are able to move so as to install all the screws. Insert valves (13,24,86) and retainer (33a) in housing.

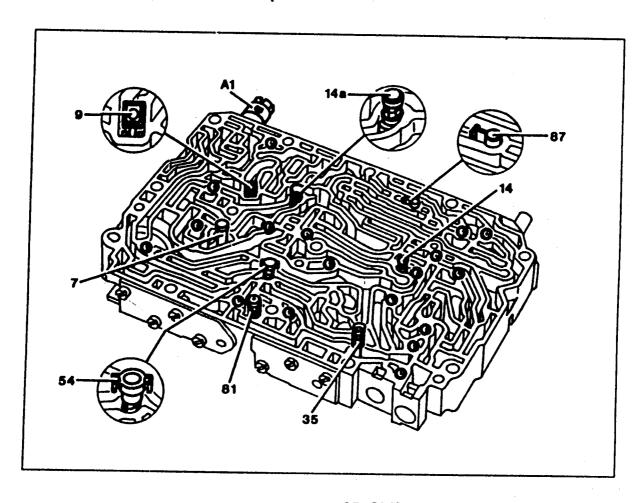
- A1 Manual Valve
- 7 Shift valve K1
- 9 Check valve (white)
- 14 check balls (19)
- 14a Pressure valve

- 35 Shift pin lube pressure
- 54 Check valve
- 81 Sieve filter
- **87 THrottle Valve**

Remove all 19 check balls (14), The valve ball marked with 14 is positioned on a conical spring.

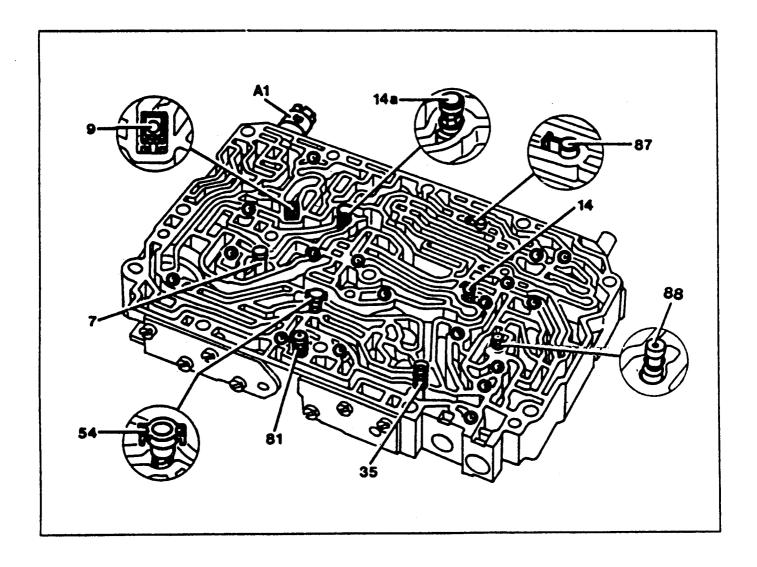
# **Mercedes Model 722.4**

- A1 Selector Valve
- 81 Strainer
- 7 Locking valve K1
- 9 Check valve without bore
- 14 Valve balls (18or 19)

- 14a Pressure valve (check ball)
- 54 Check valve
- 87 Restrictor valve K2
- 35 Lubricating pressure shaft spring
- 88 Check valve with restrictor

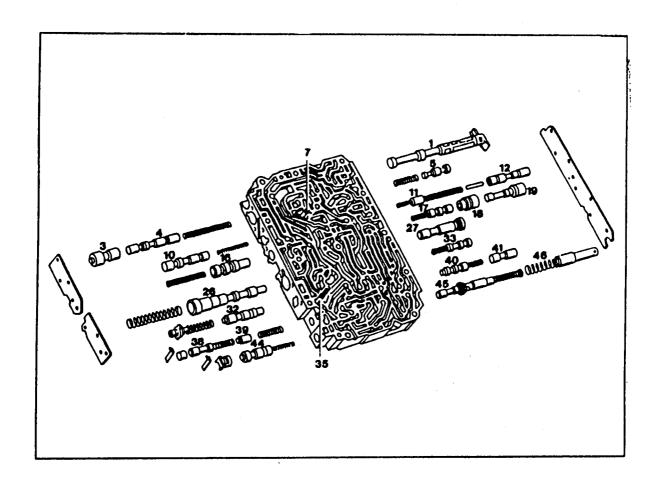
- 1 Manual Valve
- 3 Piston control valve 2-3
- 4 Control valve 2-3
- 5 Regulator valve Torque Conv.
- 7 Lock-out valve K1
- 10 Shift valve B1
- 11 Piston control valve 3-4
- 12 Control Valve 3-4
- 16 Regulation valve basic press.
- 17 Control Valve 1-2
- 18 Sleeve control valve 1-2
- 19 Piston control valve 1-2

- 26 Regulator valve oper. press.
- 27 Plug, Shift valve Ku
- 32 Regulator valve, Full TV
- 33 Shift valve B2
- 35 Shift pin lube press.
- 38 Regulator valve B1
- 40 Shift valve, kick down
- 41 Shift valve Gov. Press.
- 44 Amplification Valve Gov.
- 45 Regulator valve, cont.l pressure
- 46 Piston, regulator valve control pressure.

The arrow indicates the position of the allen screw for full throttle control pressure. Turning clockwise results in earlier full load or kick-down upshifts. Turning counterclockwise results in later upshifts.

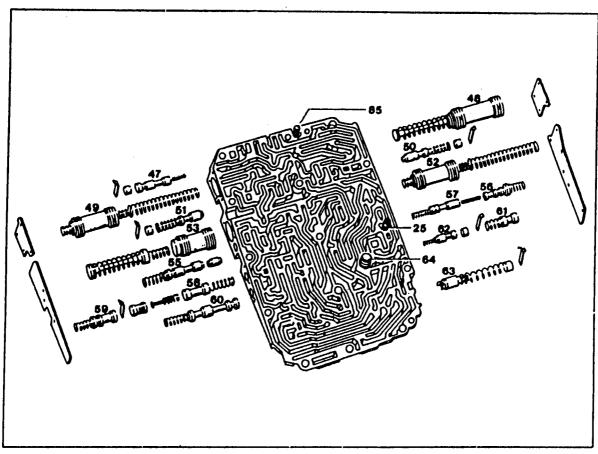
- 25 Relief valve (modulator press)
- 47 Regulator valve shift pattern
- 48 Damper K1
- 49 Damper K2
- 50 Regulator valve damper K1
- 51 Regulator valve damper K2
- 52 Damper B1
- 53 Damper switch on
- 55 Lock-out valve RB2
- 56 Shift valve deceleration

- 57 Regulator valve damper B1
- 58 Regulator valve damper, switch on59
- 59 Shift valve K2
- 60 Release valve B2
- 61 Lock-out valve deceleration
- 62 Lock-out valve RV1
- 63 Damper, kick-down
- 64 Lubrication pressure valve
- 85 Pressure limitation valve.

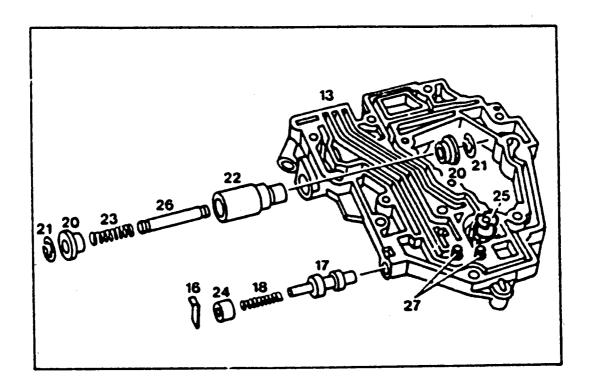
- 13-Bottom cover
- 16-Retaining plate
- 17-Secondary pump check valve
- 18-Spring
- 20-Bushing
- 21-Locking element
- 22-Locking valve
- 23-Spring
- 24-Plug
- 25-Valve
- 26-Pin
- 27-Strainer

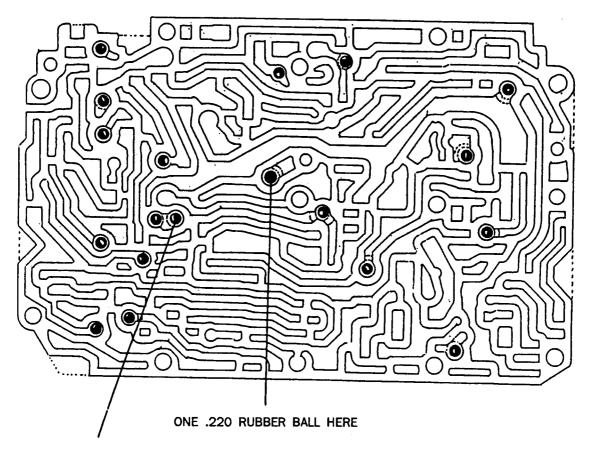
# UPPER VALVE BODY (BOTTOM VIEW)

(18) .215 STEEL CHECK BALL LOCATIONS

PLACE SPRING UNDER THIS BALL

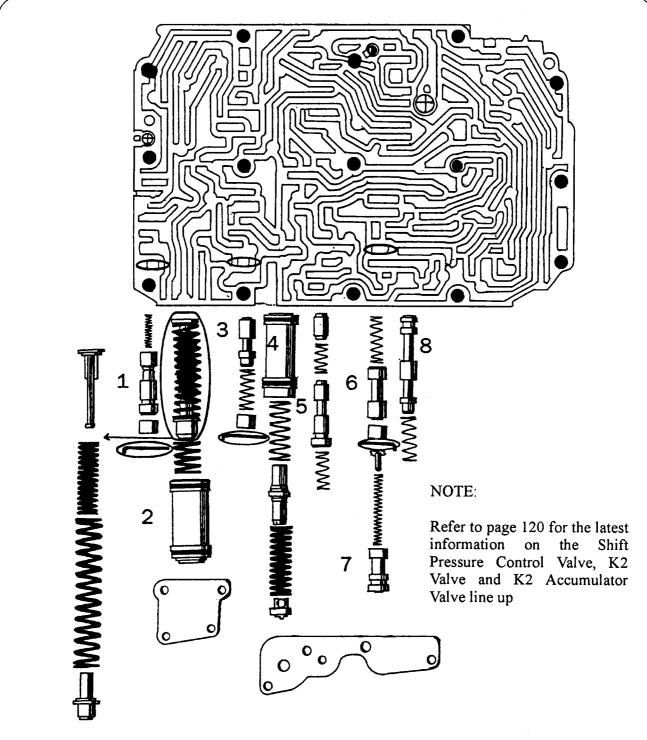
# Technical Service Information LOWER VALVE BODY (BACK VIEW)

- 1. SHIFT CONTROL PRESSURE VALVE
  2. K2 ACCUMULATOR
  3. K2 ACCUMULATOR CONTROL VALVE
- 4. ACCUMULATOR SWITCHING ON
- 5. RV2 SHUT OFF VALVE
  6. ACCUMULATOR SWITCHING ON CONTROL VALVE
  7. K2 SHIFT VALVE
- 8. B2 DETENT VALVE

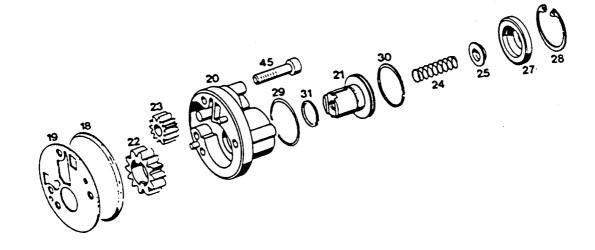
# **REAR PUMP ASSEMBLY**

18-O-ring

19-Intermediate plate

Oil pump gears (22 and 23) and insert into pump housing. Insert driven pump gear (22) so that drive lug (arrow) points upwards.

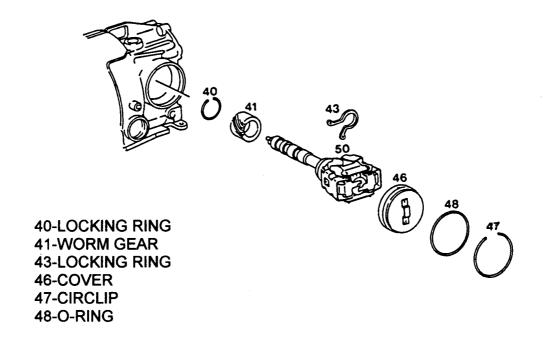
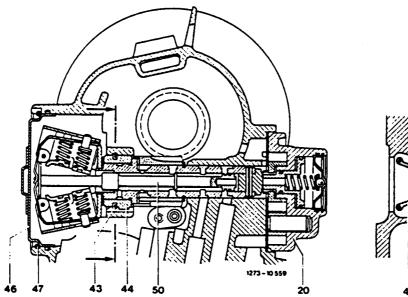
# **GOVERNOR ASSEMBLY**

20-SECONDARY PUMP 43-LOCKING RING 44-BEARING RING 46-COVER 47-CIRCLIP

20-Remove O-ring (29). Check all parts for damage and wear. The gap in the two Teflon rings (30 and 31) should bell the way together, no gap, if necessary insert Teflon ring into grooves with a small quantity of grease.

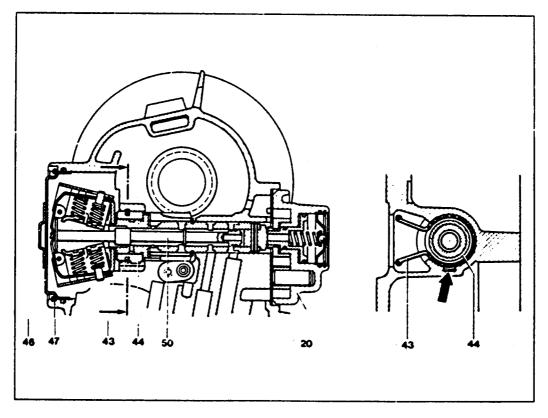
## **GOVERNOR ASSEMBLY 722.4**

20-SECÖNDARY PUMP 43-LOCK RING 44-BEARING RING 46-COVER 47-LOCK RING 50-GOVERNOR

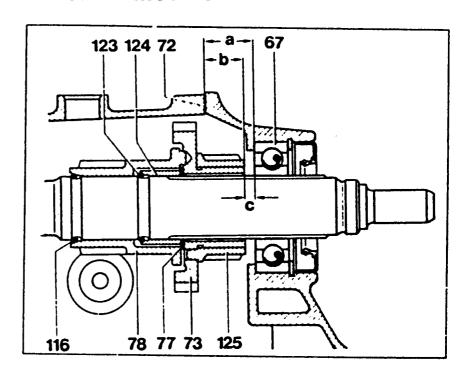
## Determining size "a"

107a-Measure end play (C) of output shaft (clutch K2) and compensate.

Place measuring disc (028) 129 589 06 23 00 onto the sealing face of the rear cover. Measure with the depth gauge from the measuring disc (028) to the ball bearing inner race (67).

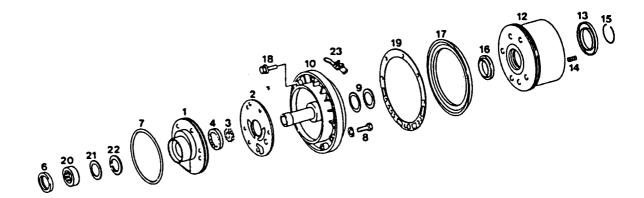
# FRONT PUMP ASSEMBLY

1-Pump housing

2-Intermediate plate

Clean surfaces replace pump gasket do not use any sealant on the gasket. The bolts shoult have a non-hardening sealant torque bolts to 13 Nm.

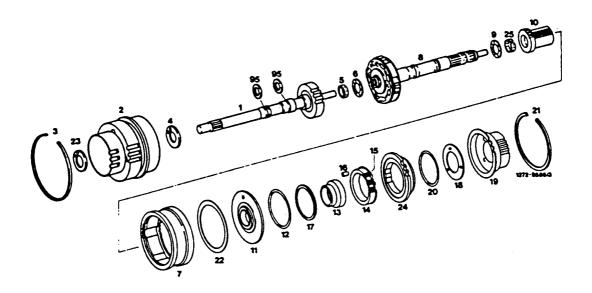
# PLANETARY ASSEMBLY

1	Input shaft	Check for damage and wear
2	Front gear assembly	Check for damage and wear
3		
4	Axial bearing	Check for damage and wear
5	Radial bearing	Check for damage and wear
6	Axial bearing	Check for damage and wear
7	Connection carrier	
8	Output shaft	Check for damage and wear
9	Axial bearing	Check for damage and wear
10	Sun gear behind gear assembly	Check for damage and wear
11	Supporting disk	Check for damage and wear
12	O-ring.	Renew
13	One-way roller clutch-inner race	Check for damage and wear
14	Roller cage	Check for damage
15	Compression springs	•
16	Cyl. rollers	Check for damage and wear
17	Compensating ring	•
18	Thrust washer	Check for damage and wear
19	Inner plate carrier K2 with one-way roller	
	clutch-outer race	Check for damage and wear
20	O-ring	Renew
21	Circlip	
22	Compensating washer	Measure or exchange, if required
	Axial bearing	Check for damage and wear
24	One-way roller clutch-outer race	Check for damage and wear

25	Redial bearing	Check for damage and wear
95	Lubrication thrust rings	Renew

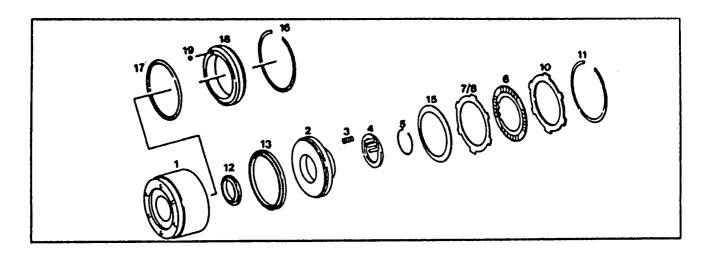
#### DISASSEMBLY, ASSEMBLY AND MEASUREMENT OF K1 CLUTCH

Retaining ring (11) Plate assembly (6,7,8 and 10 plate	remove with screw driver .Install		
spring (15)	Remove completely from hub (1). Install. Position in sequence according to transmission type. Position plate spring with crown toward piston .Check and adjust release clearance.		
retaining ring (5)	remove, install. For this purpose compress spring plate until retaining ring is exposed.		
Spring plate (4) and pressure springs (3)	remove and check number of springs.		
piston (2)	Pull out, To install piston use installation tool.		
O-ring (17)	Test for leakage.		
Piston guide ring (18)	Remove after removing retaing ring.

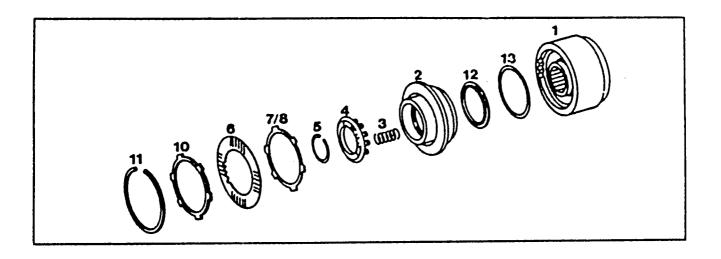
## DISASSEMBLY, ASSEMBLY AND MEASUREMENT OF K2 CLUTCH

Retaining ring (11)	remove with screw driver, install	
Plate assembly (6,9 and 10)  Retaing ring (5)	remove completely from outer plate carrier(1). Install. Position in sequence according to transmission type. After installation check and adjust clearance. remove,install. For this purpose compress spring plate (4) until retaining ring is exposed.	
Spring plate (4) and pressure springs (3)	remove, spring retainer (4)	
Piston (2)	pull out, To install piston use installation sleeve. Install new seals with lip facing down	
O'ring in outer plate carrier (1)	check for leakage with kerosene.

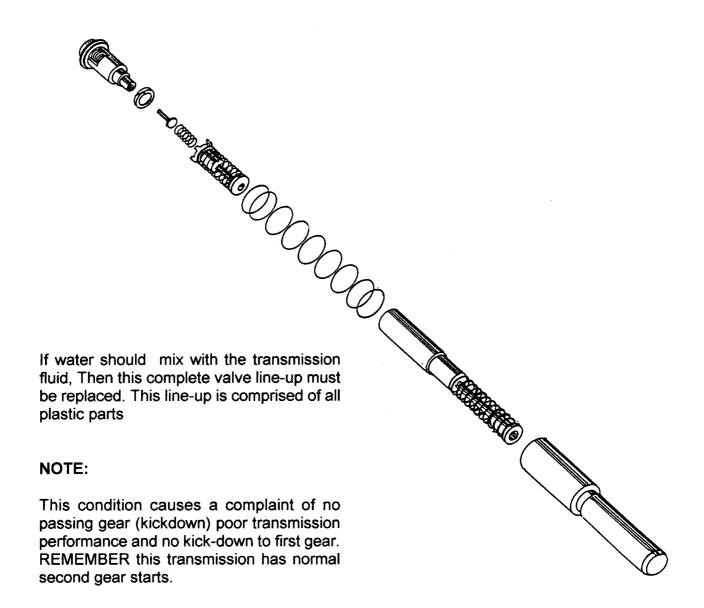
The TV valve line-up is different in the Mercedes models 420 SEL, 560 SEL and SL models. This change was made the the 1986 model year. Figure 1 illustrates the valve line-up.

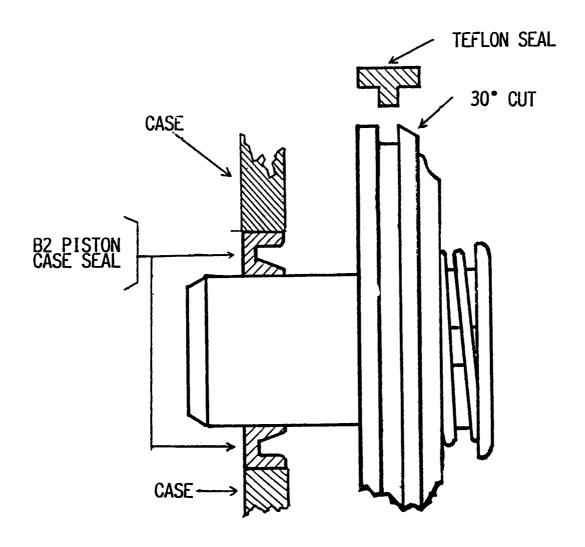
CAUSE: The B2 piston seal has been replaced with the late type. Part # 107 270 04 32 that is the "T" type teflon seal. The "T" type seal is not flexible and does not seal well against the servo bore wall.

CORRECTION: Make a 30 degree chamfer around the out diameter of the top (outside land) on the piston. The servo cover side, as shown in Figure 1.

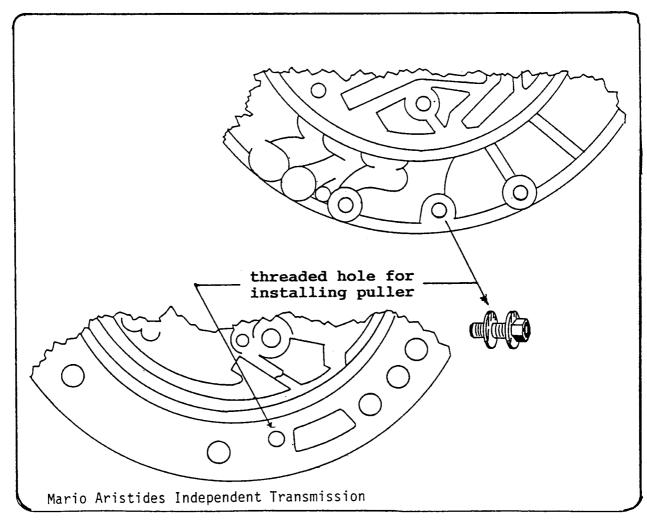
# Mercedes 722.3 Early Version 1980-84 (6 bolt pan)

CAUSE: The threaded hole in the pump body for the use of a pump puller was originally drilled through the pump support up thru 1984. When installing the pump puller the threads in the pump support are pushed above the surface of the support causing a cross leak with the B3 or reverse clutch apply hole. The Ifluid leaks past the gasket and comes out the hole that the puller was installed in. The later models DO NOT have the hole drilled completely through the pump support.

**CORRECTION:** Take a hand grind stone and resurface the support and the case at both the bolt hole in the pump cover and B3 clutch hole. Use a sealer on both sides of the gasket and take a pan bolt from an AXOD and and a GM pump sealing washer and install in the hole in the pump body that the puller is used in.

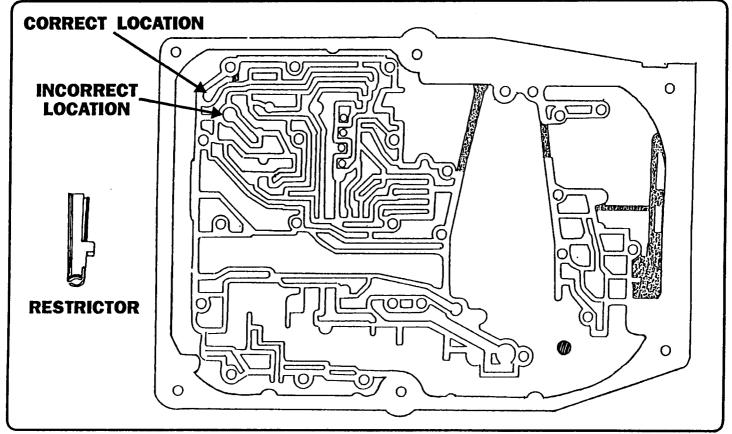
Figure 1

**CAUSE:** The reverse feed passage is unrestricted, allowing too much oil volume to the reverse clutches.

**CORRECTION:** Install the Mercedes tapered oil restrictor Part no. 123 277 0319. into the transmission case as shown in Figure 1. Note that the restrictor goes in tapered end first and fits snug in the case.

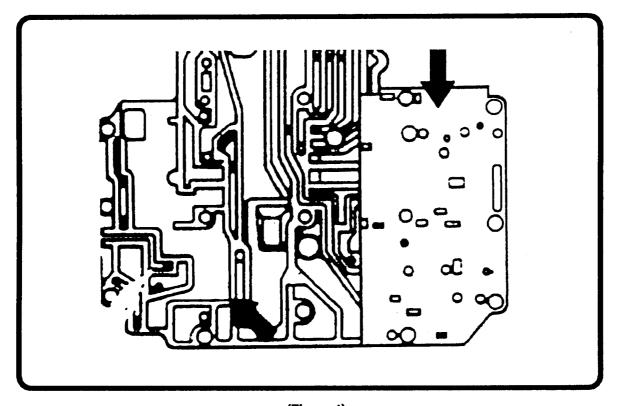
(Figure 1)

A leak in the transmission fluid cooler allows coolant to enter the transmission. This will change the friction coefficient of the friction linings in the transmission.

- a. Transmission fluid has milky discoloration.
- b. Transmission fluid foams heavily when drained.
- c.The gasket on the large intermediate plate shows severe swelling or a green slimy coating (upper right arrow in Figure 1). d.The intermediate plate shows signs of corrosion under the
- gasket (lower left arrow in Figure 1).

replace radiator and all friction linings in the transmission.

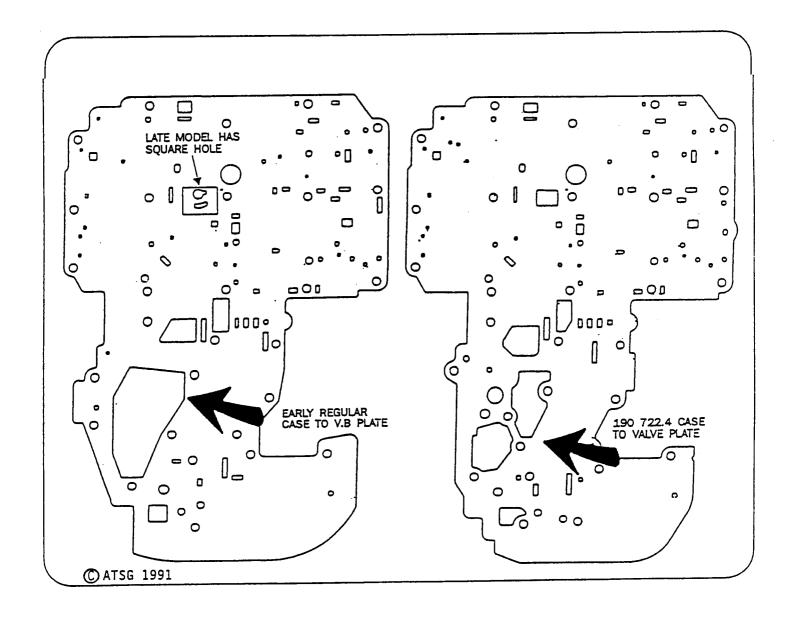
# MERCEDES 722.3 / 722.4 SEPARATOR PLATE IDENTIFICATION

We have illustrated the separator plate ID in Figure 1 for both the regular 722.3 valve body and the 722.4 which is the 190E plate. You will note that the "regular" six bolt pan plate has a large opening where as the 190E opening is split. The arrows point to the locations on the plate. The regular plate (722.3) has a late and early version. The early will NOT fit the late valve body but the late will fit the early. Note the difference. The late has a square hole instead of the two orifices in the early. This is the position of the valve body screen.

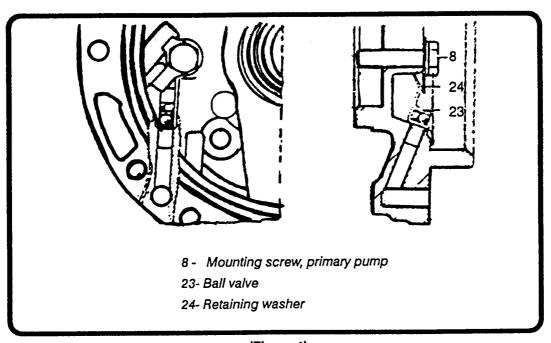
(Figure 1)

Ball valve in the front transmission cover is defective.

Replace ball valve, part #201 270 03 89, and install retaining washer (24), part

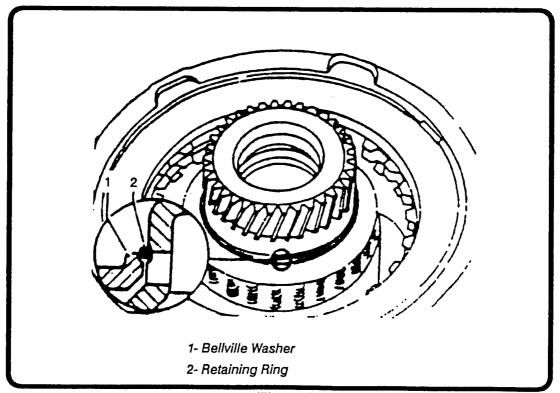
(Figure 1)

Replace steel disks K-1, bellville washer, and retaining ring (Figure 1).

If the transmission is disassembled for repairs, check to be sure the retaining ring sits properly in it's groove, or if the bellville washer already is pushed over the retaining

ring. In this case, replace steel disks K-1, retaining ring, and bellville washer.

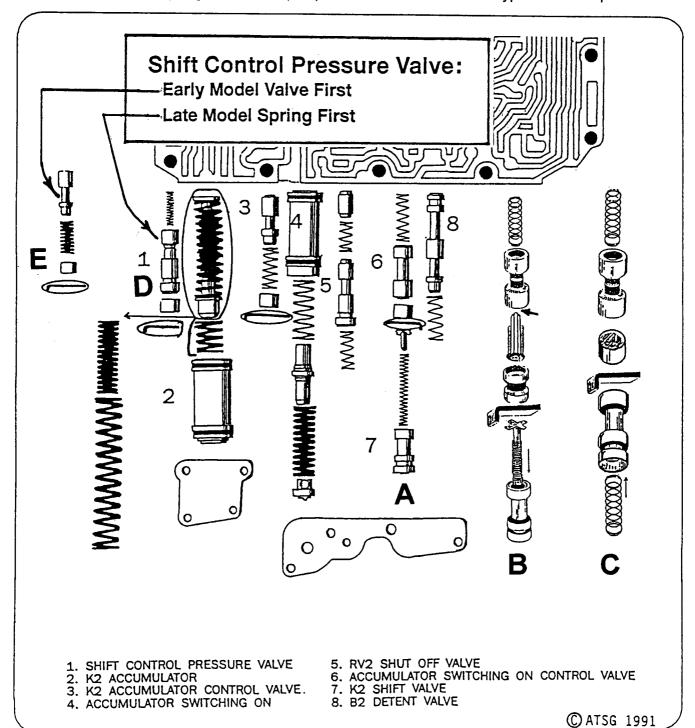
There are three versions of the K2 shift valve line-up in the lower valve body, we have illustrated these in the illustration below. Line-up "A" is the second and most common version. The "C" line-up is the first version. The "B" line-up was first found in the 722.4 and became the third version in the late model 722.3.

The "D" and "E" shift control pressure valves can be found to be installed valve first then spring (early) or spring than valve (late). Be sure to check valve type and line-up.
